Contract #: 04-0120F4Cty: SF/ALA Rte: 80 PM: 13.2/13.9File #: 99.28**WELDING INSPECTION REPORT****Resident Engineer:** Casey, William**Address:** 333 Burma Road**City:** Oakland, CA 94607**Report No:** WIR-029181**Date Inspected:** 27-Feb-2013**Project Name:** SAS Superstructure**OSM Arrival Time:** 700**Prime Contractor:** American Bridge/Fluor Enterprises, a JV**OSM Departure Time:** 1530**Contractor:** USA Hoist**Location:** USA Hoist, Crest Hill, IL

Bridge No: 34-0006**Component:** SAS Tower Elevator**Summary of Items Observed:**

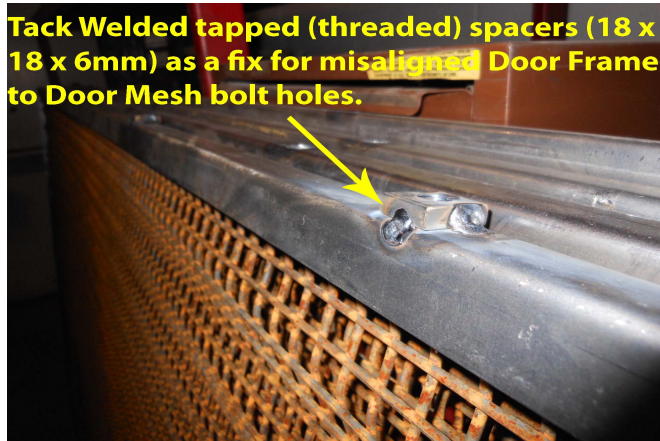
Welder Wasigi was also observed welding tapped (threaded) spacers as nuts for the door mesh M8 x 25MM LG, FHCS mounting bolts at locations where the door mesh nuts and the door frame bolt holes do not align at door frame mesh 1, 2, 3, 4, 5 & 6. The welder was using 1.1mm E71T-1C Familiarc DW-50 wire electrode with a combination of 75% Argon and 25% CO2 with flow rate of 37 CFH. The welding parameters measured were 26 volts and 195 amperes and were in compliance with the Welding Procedure Specification (WPS) FCAW3210.

Tack Welded tapped (threaded) spacers (18 x 18 x 6mm) as a fix for misaligned Door Frame to Door Mesh bolt holes.

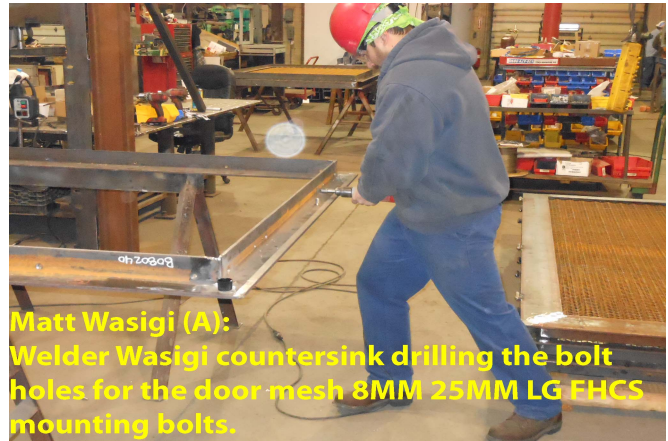
Welder Wasigi was observed removing the temporary mounting bolts of the Door Mesh to the Door Frame and countersink drilling the door stop bolts holes for the door mesh M8 x 25MM LG, FHCS mounting bolts for doors 1, 2, 3, 4, 5 & 6.

**Matt Wasigi (A):
Welder Wasigi countersink drilling the bolt holes for the door mesh 8MM 25MM LG FHCS mounting bolts.**

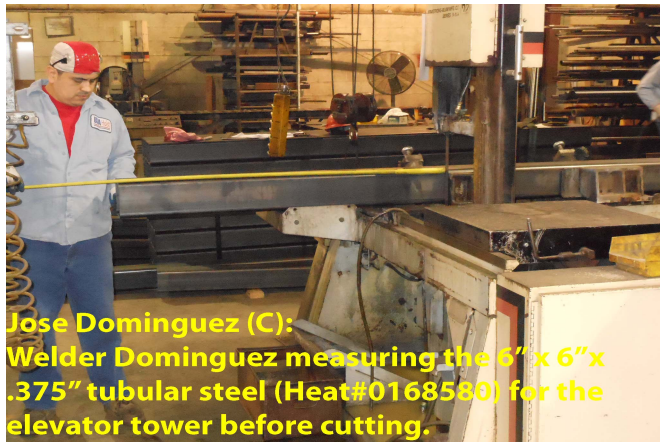
Welder Dominguez was observed continuing with machine cutting 6" x 6"x .375" tubular steel (Heat#0168580) for the elevator tower to the specified lengths. Cutting will continue on the following shift.

**Jose Dominguez (C):
Welder Dominguez measuring the 6" x 6" x .375" tubular steel (Heat#0168580) for the elevator tower before cutting.**
